**Wright Inspections LLC**  
PO Box 605  
Maricopa AZ 85139  
480-558-6182      Daren@WrightinspectionsAZ.com  
**Daren Wright, AZ Certification #50446**  
Address: [REDACTED]

## **Confidential Inspection Report**

### **Maricopa AZ 85138**

**Prepared for: Joe Sample**  
**Inspector: Daren Wright, Certification # 50446**

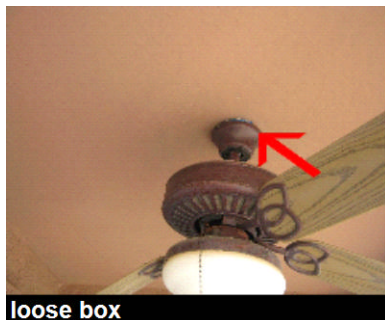
**\*\*\*** One or more of the exterior light fixture were not operating or damaged. Repair or replacement is recommended. The patio coachlight does not function, and ceiling fan is damaged and improperly mounted.

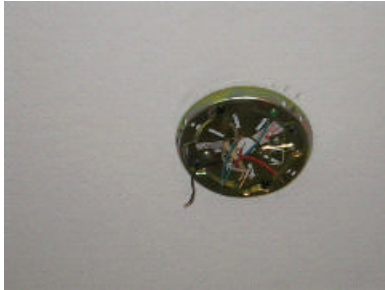
\*\*\* Several of the light fixtures were missing from the area and their wiring was left exposed. We recommend properly installed fixtures be installed.

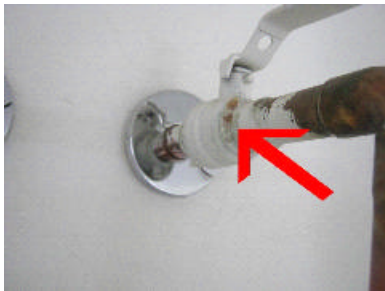
\*\*\* The cold water feed shut off valve was corroded and shows signs of past "pin holing". We recommend that this valve be replaced as part of a comprehensive preventative maintenance program.

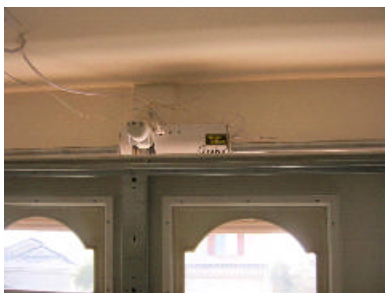
\*\*\* The garage door opener failed to open the door completely when operated by normal controls. We recommend further evaluation and repair or replacement of the unit. Temp batteries were installed in the wall mounted remote to test the opener. New batteries should be installed.

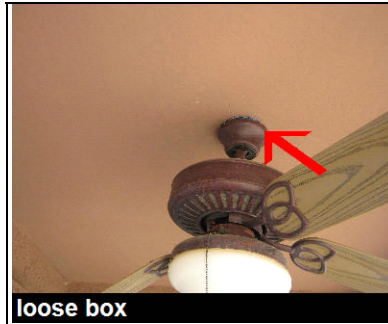
\*\*\* One or more of the exterior light fixture were not operating or damaged. Repair or replacement is recommended. The patio coachlight does not function, and ceiling fan is damaged and improperly mounted.

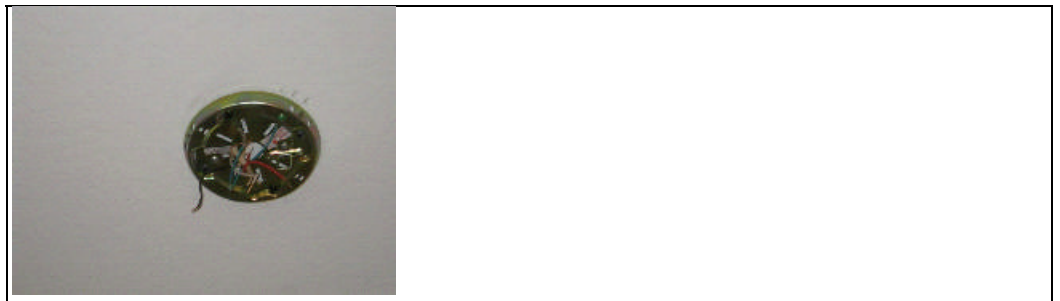
\*\*\* Several of the light fixtures were missing from the area and their wiring was left exposed. We recommend properly installed fixtures be installed.

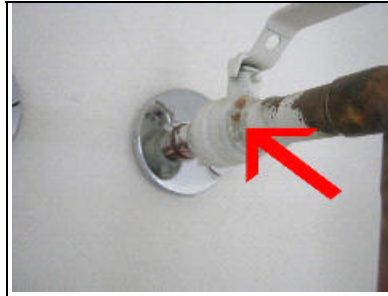
\*\*\* The cold water feed shut off valve was corroded and shows signs of past "pin holing". We recommend that this valve be replaced as part of a comprehensive preventative maintenance program.

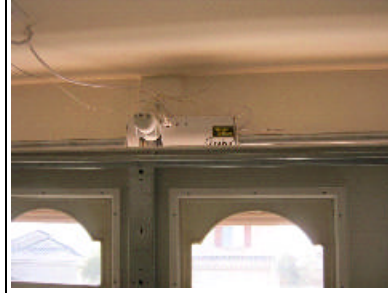
\*\*\*The garage door opener failed to open the door completely when operated by normal controls. We recommend further evaluation and repair or replacement of the unit. Temp batteries were installed in the wall mounted remote to test the opener. New batteries should be installed.
