Wright Inspections LLC
PO Box 605
Maricopa AZ 85139
480-558-6182 Daren@WrightinspectionsAZ.com
Daren Wright, AZ Certification #50446
Address: [REDACTED]

Confidential Inspection Report

Enclosed is the inspection report for the property inspection conducted for you on 01/29/2011 at [REDACTED] Phoenix, AZ 85033.

Property Address: 133 E Royal Palm Rd Phoenix, AZ 85033

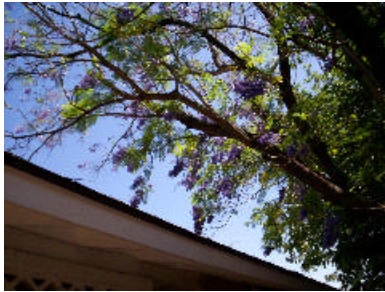
*** Trees are hanging over the roofing surfaces of this building. This can result in premature deterioration of the roofing materials due to tree sap, bird droppings, or from accumulated tree debris. We recommend that all trees be cut back to eliminate branches which overhang the roof.

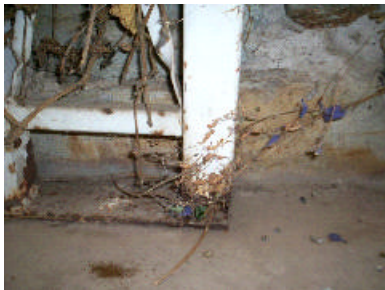
Metal trellis post

*** The metal posts were deteriorated in places at the base at the front porch roof. These trellis post are load bearing and are supporting the roof. We recommend further evaluation with remedy as necessary by a qualified and competent contractor.

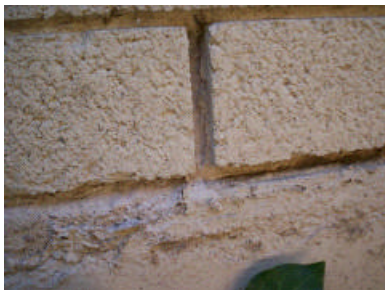
Masonry Veneer/Solid

*** The mortar at the base of the exterior masonry walls was deteriorated on more than one side. We recommend that all missing, loose or crumbly mortar be re-pointed as necessary to restore the exterior masonry. We also suggest that the exterior be properly water sealed as a preventative maintenance measure.

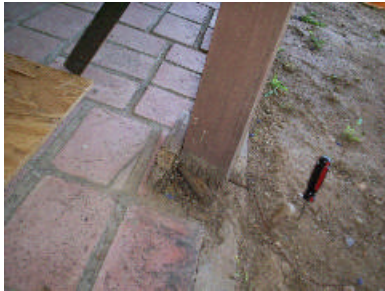
*** The patio cover posts are in contact with ground and are damaged from moisture. This condition should be corrected to prevent further deterioration.

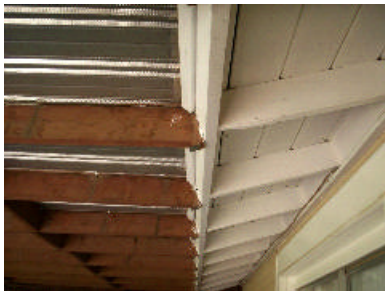
*** The support or attachment of the rear patio cover to the building was failing and movement of the structure was observed.

RECOMMENDATION: A qualified and competent contractor should evaluate the patio cover and make recommendations on improving the stability and attachment. We consider this an immediate attention item.

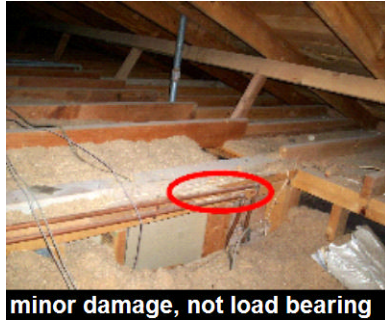
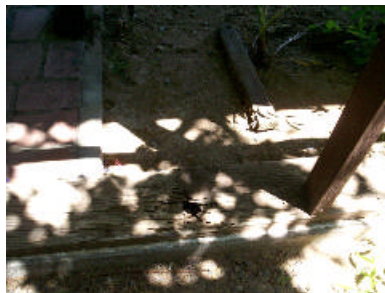
*** Evidence of wood destroying organism activity in the form of deteriorated wood was observed in several areas of the exterior and interior of the building.

RECOMMENDATION: A qualified and competent licensed pest control company should evaluate this building further with remedy as necessary.

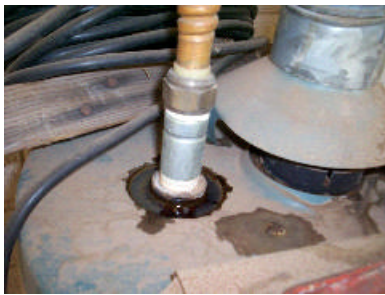
*** The water connections were corroded and leaking.

SUGGESTION: The connections should be replaced with approved components.

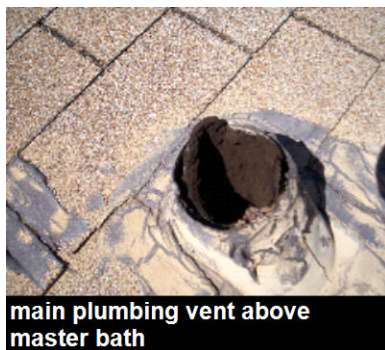
*** The vent piping in the system was extensively damaged and or deteriorated. Further evaluation by a qualified and competent plumbing contractor, with replacement or repair is recommended.

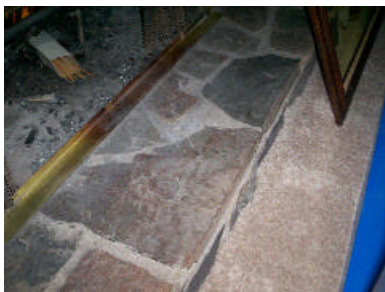
*** The hearth extension for the fireplace did not extend outward from the fire box opening the required distance to meet current industry standards. Due to inadequate clearance to combustible materials, additional non combustible material should be installed in accordance with current standard clearances for an improved margin of fire safety.

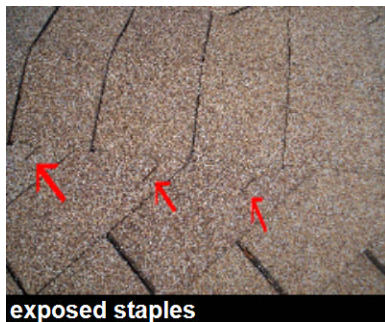
*** Shingle fasteners were exposed (visible) in several areas. This indicates an improper overlap of the shingles and is an unapproved method of installation.

RECOMMENDATION: This roofing should be further evaluated with remedy as necessary by a qualified and competent roofing contractor.

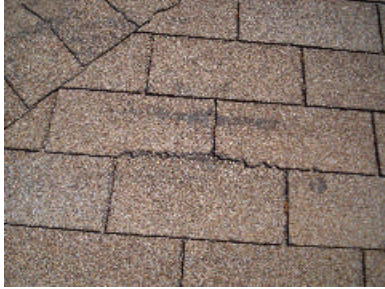
*** Tree branches have caused premature wear and mechanical damage to the roof surfaces. These surfaces should be evaluated by a competent and licensed roofing contractor.

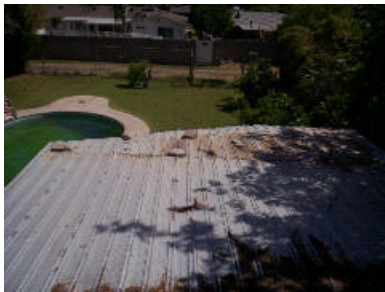
Metal Roof Surface

*** The metal roofing was bent and wind damaged in one or more areas. Moisture leakage is probable.

RECOMMENDATION: We recommend further evaluation with remedy as necessary by a qualified and competent roofing contractor.

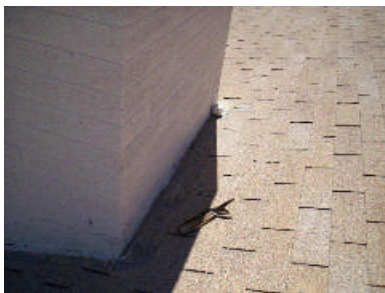
Cricket Flashings

*** No appropriate drainage cricket or "saddle" is installed at the wide fireplace chimney. We strongly recommend that a properly designed cricket be installed at the chimney when the roofing is replaced at some point in the future. In the mean time, the condition of the roof behind the chimney should be monitored with maintenance performed as necessary to prolong the roof life in this ponding water area.

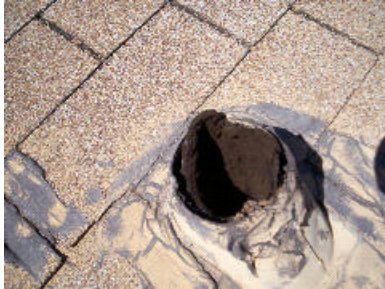
Plumbing Vents

*** One or more of the plumbing vents was plugged. These should be unplugged to properly vent the system.

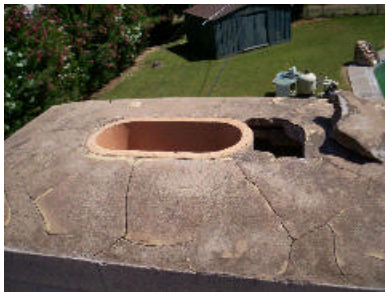
Chimney On Roof

*** The chimney was in acceptable condition. However, no spark or rain cap had been installed above the flue to prevent the escape of hot embers or rain entry. SUGGESTION: As an upgrade, a chimney spark arrester/rain cap should be installed.

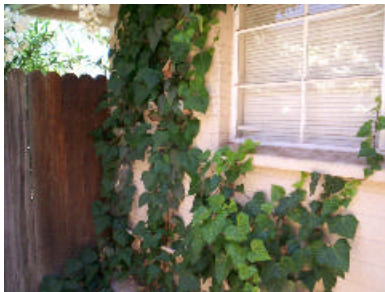
*** Vines are growing on the exterior of this building. Vines can prematurely damage the paint and the exterior building surfaces and we suggest that vines be removed or grown on trellises mounted off the surface of the building exterior.

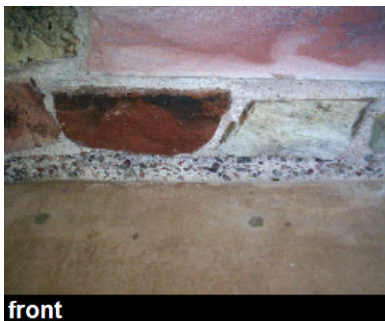
*** "Spawling" or deterioration to the surface of the concrete stemwalls was noted. This condition is usually due to moisture entry into the concrete stemwalls and perpetuates moisture penetration by making the surface of the stemwalls more porous. We suggest attention to this condition by restoring the smooth surface to the stemwall and eliminating the source of moisture which has caused this deterioration.

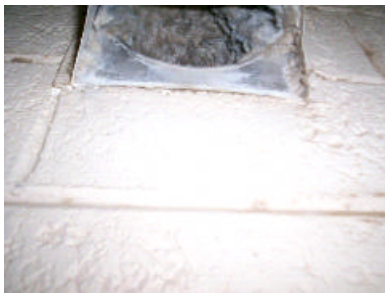
*** The clothes dryer vent had become clogged with lint, dirt or debris. This is a fire hazard and reduces drying efficiency.

SUGGESTION: This dryer's duct should be disassembled and cleaned to eliminate the clog as a safety item needing immediate attention. *** The flapper was stuck in the open position on the exterior wall of the home. This can allow unconditioned air into the home and small animals may be able to enter. We recommend repair to restore the operation of the flapper on this opening.

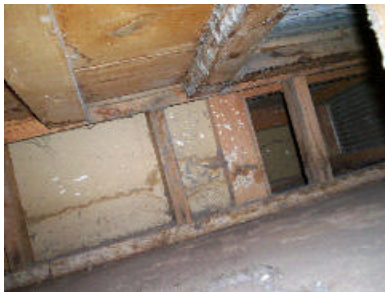
*** The return air flowed through a space under the ac closet. this area contained dirt and dust which can clog the air filter reducing efficiency. This area also showed signs of past moisture intrusion. This may have been caused by condensation leaking from the HVAC system . Proper maintenance and monitoring will prevent this from becoming a source of mold and mildew.

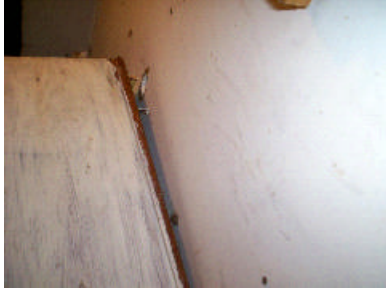
*** The base cabinet in the laundry room was damaged. We suggest further evaluation with remedy as necessary by a qualified and competent contractor.

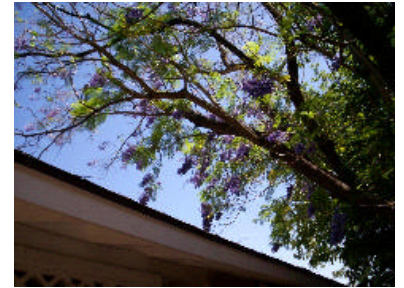
*** Trees are hanging over the roofing surfaces of this building. This can result in premature deterioration of the roofing materials due to tree sap, bird droppings, or from accumulated tree debris. We recommend that all trees be cut back to eliminate branches which overhang the roof.

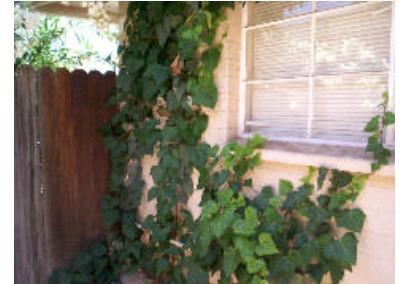
*** Vines are growing on the exterior of this building. Vines can prematurely damage the paint and the exterior building surfaces and we suggest that vines be removed or grown on trellises mounted off the surface of the building exterior.

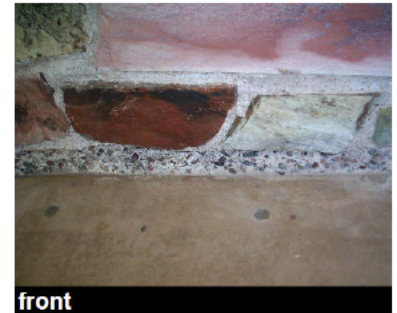
*** "Spawling" or deterioration to the surface of the concrete stemwalls was noted. This condition is usually due to moisture entry into the concrete stemwalls and perpetuates moisture penetration by making the surface of the stemwalls more porous. We suggest attention to this condition by restoring the smooth surface to the stemwall and eliminating the source of moisture which has caused this deterioration.

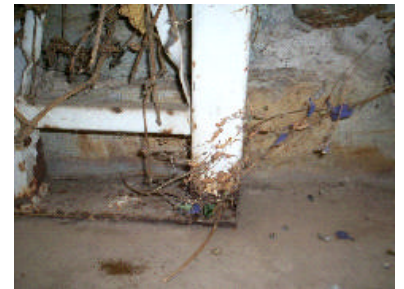
*** The metal posts were deteriorated in places at the base at the front porch roof. These trellis post are load bearing and are supporting the roof. We recommend further evaluation with remedy as necessary by a qualified and competent contractor.

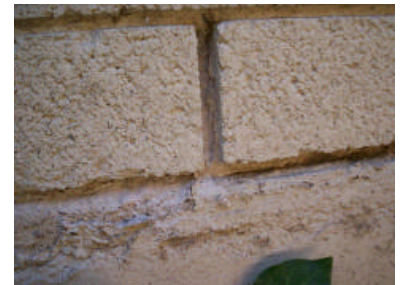
Masonry Veneer/Solid

*** The mortar at the base of the exterior masonry walls was deteriorated on more than one side. We recommend that all missing, loose or crumbly mortar be re-pointed as necessary to restore the exterior masonry. We also suggest that the exterior be properly water sealed as a preventative maintenance measure.

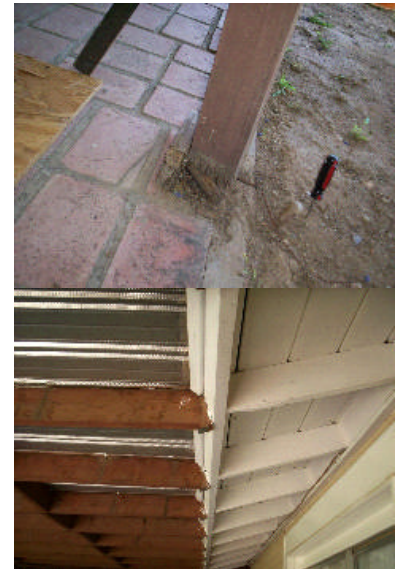
*** The support or attachment of the rear patio cover to the building was failing and movement of the structure was observed.
RECOMMENDATION: A qualified and competent contractor should evaluate the patio cover and make recommendations on improving the stability and attachment. We consider this an immediate attention item.

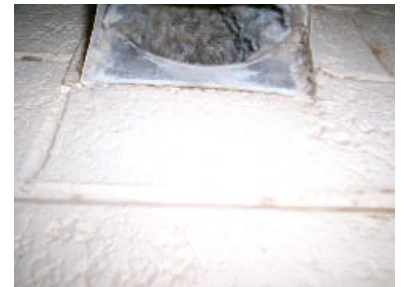
*** The clothes dryer vent had become clogged with lint, dirt or debris. This is a fire hazard and reduces drying efficiency.
SUGGESTION: This dryer's duct should be disassembled and cleaned to eliminate the clog as a safety item needing immediate attention. *** The flapper was stuck in the open position on the exterior wall of the home. This can allow unconditioned air into the home and small animals may be able to enter. We recommend repair to restore the operation of the flapper on this opening.

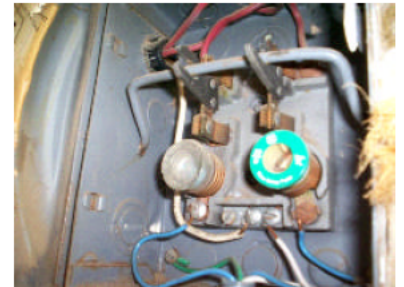
The branch circuit overload protection was provided by a mix circuit breakers, cartridge type fuses, and glass fuses. . This is an antiquated type of circuit overload protection. Although no adverse conditions were visible at the time of our inspection. We suggest that an upgrade of the electrical service and sub-panels with glass fuses, be considered.

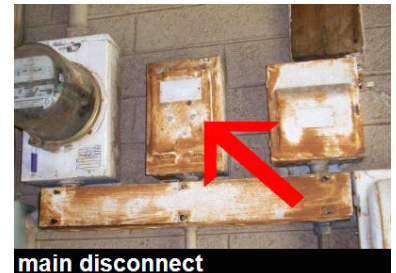
main disconnect

The Main Electrical Service Disconnect was a single throw, cartridge type located in a separate box next to the meter.

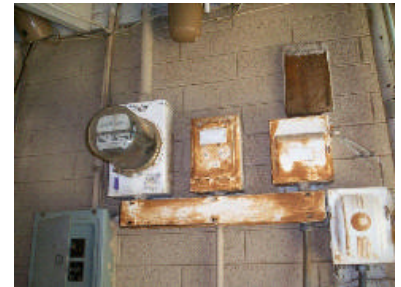
The Main Service Panel was in acceptable condition with the circuitry installed and protected for the period when it was installed. The service panel would not meet current requirements, but upgrading is not required at this time, and would usually only be considered along with other improvements.

*** The clearance in front of this electrical panel did not conform to current industry standards. We recommend removal of anything within 36 inches of the front or 30 inches on the sides of this panel for an improved margin of electrical safety.(AC compressor)

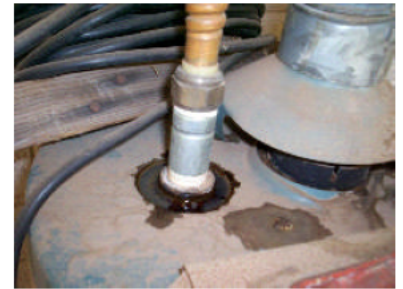
*** The water connections were corroded and leaking.
SUGGESTION: The connections should be replaced with approved components.

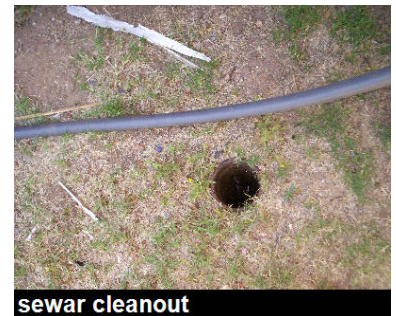
*** A main sewer cleanout was located on the exterior in the rear of the building. This was found to be exposed and uncapped and may have debris inside of it. We recommend proper evaluation and capping of pipe by a competent and qualified plumber.

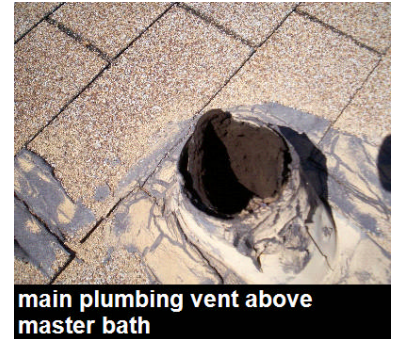
*** The vent piping in the system was extensively damaged and or deteriorated. Further evaluation by a qualified and competent plumbing contractor, with replacement or repair is recommended.

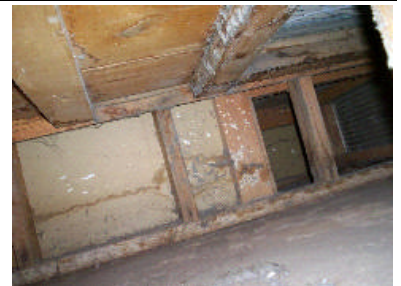
*** The return air flowed through a space under the ac closet. this area contained dirt and dust which can clog the air filter reducing efficiency. This area also showed signs of past moisture intrusion. This may have been caused by condensation leaking from the HVAC system . Proper maintenance and monitoring will prevent this from becoming a source of mold and mildew.

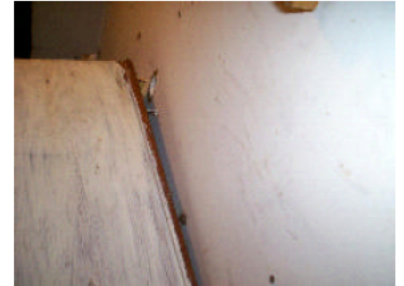
*** The base cabinet in the laundry room was damaged. We suggest further evaluation with remedy as necessary by a qualified and competent contractor.

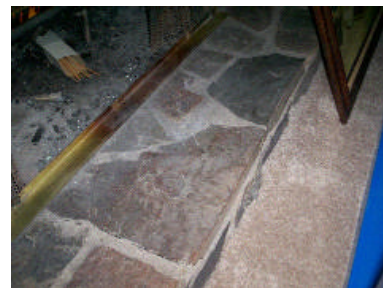
*** The hearth extension for the fireplace did not extend outward from the fire box opening the required distance to meet current industry standards. Due to inadequate clearance to combustible materials, additional non combustible material should be installed in accordance with current standard clearances for an improved margin of fire safety.

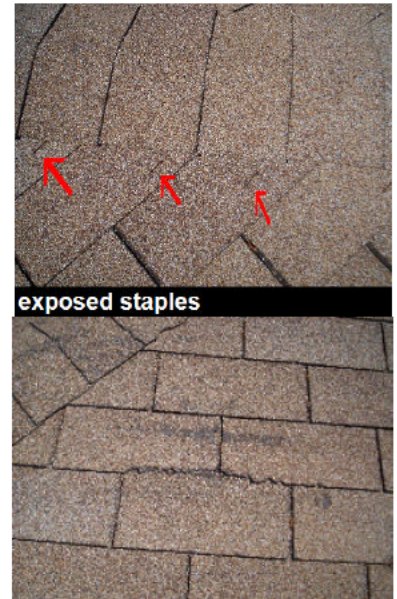
***Tree branches have caused premature wear and mechanical damage to the roof surfaces. These surfaces should be evaluated by a competent and licensed roofing contractor.

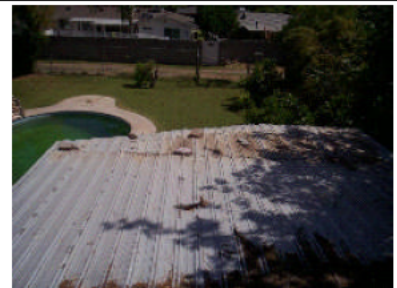
Metal Roof Surface

*** The metal roofing was bent and wind damaged in one or more areas. Moisture leakage is probable. *RECOMMENDATION:* We recommend further evaluation with remedy as necessary by a qualified and competent roofing contractor.

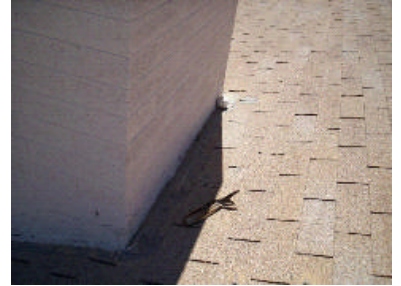
Cricket Flashings

*** No appropriate drainage cricket or "saddle" is installed at the wide fireplace chimney. We strongly recommend that a properly designed cricket be installed at the chimney when the roofing is replaced at some point in the future. In the mean time, the condition of the roof behind the chimney should be monitored with maintenance performed as necessary to prolong the roof life in this ponding water area.

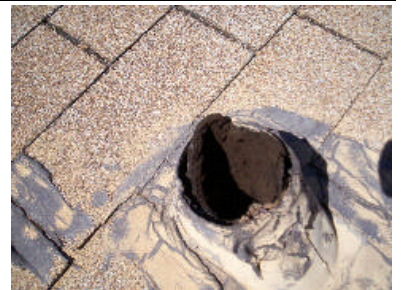
*** One or more of the plumbing vents was plugged. These should be unplugged to properly vent the system.
