Wright Inspections LLC
PO Box 605
Maricopa AZ 85139
480-558-6182 Daren@WrightinspectionsAZ.com
Daren Wright, AZ Certification #50446
Address: [REDACTED]

Confidential Inspection Report

Enclosed is the inspection report for the property inspection conducted for you on 01/29/2011 at [REDACTED] Phoenix, AZ 85033.

Property Address: 133 E Royal Palm Rd Phoenix, AZ 85033

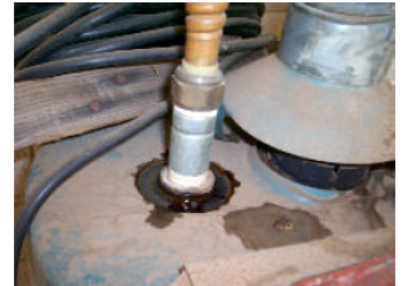
T-P Discharge Pipe

*** The temperature and pressure valve installation did not include a discharge pipe routed to an approved location.

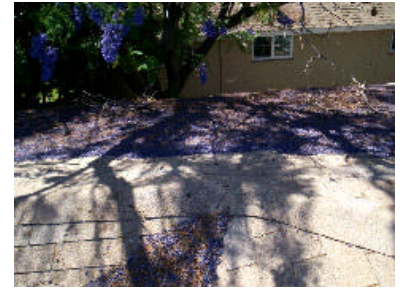
Moss and/or debris from trees was observed on the roof surface. This will restrict drainage of the roof, gutters and downspouts.

SUGGESTION: Debris on the roof should be removed to reduce the potential for damage to the roof, and reduce the potential for moisture intrusion on the building.
